NIST NCSTAR 1-5A

Federal Building and Fire Safety Investigation of the World Trade Center Disaster

Visual Evidence, Damage Estimates, And Timeline Analysis

(Chapter 9 - Appendix C)

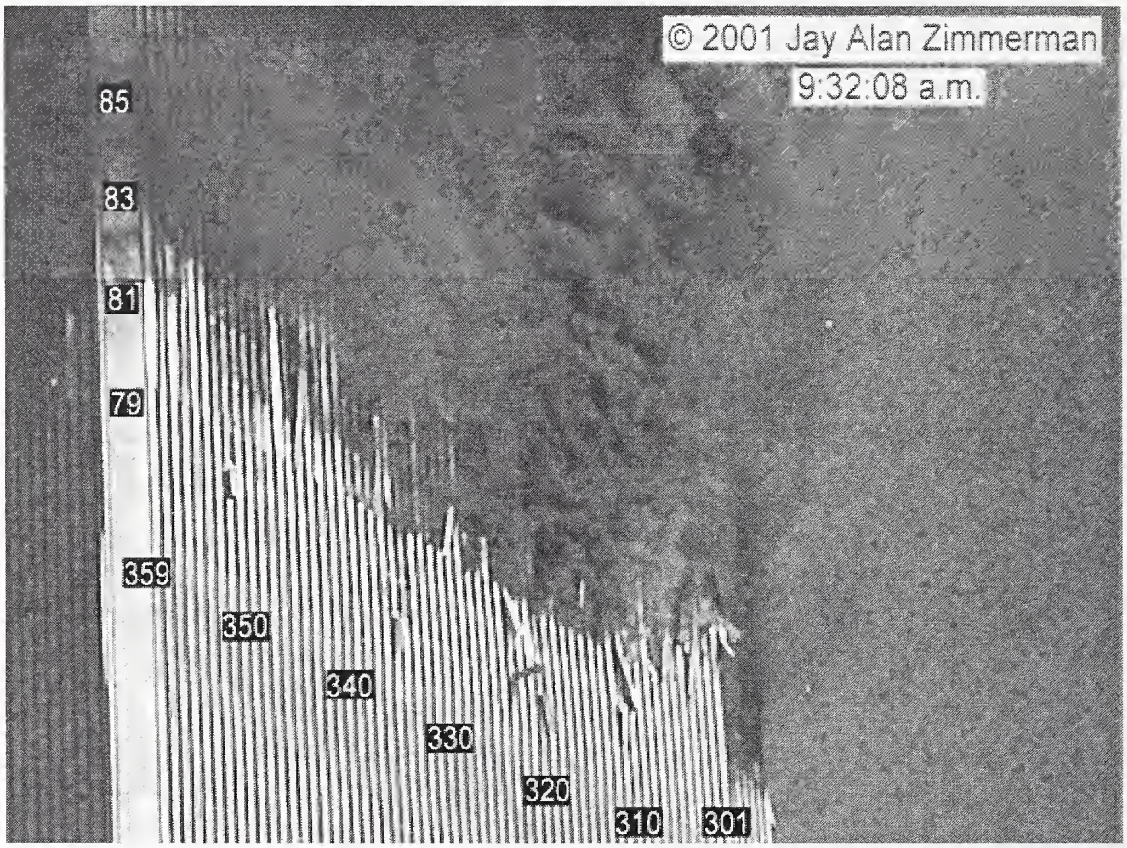
Figure 9-39. This view of the east face of WTC 2 is a frame from a video taken at 9:32:08 a.m. Column and floor numbers have been added. The northeast corner of WTC 1 is visible in the background.

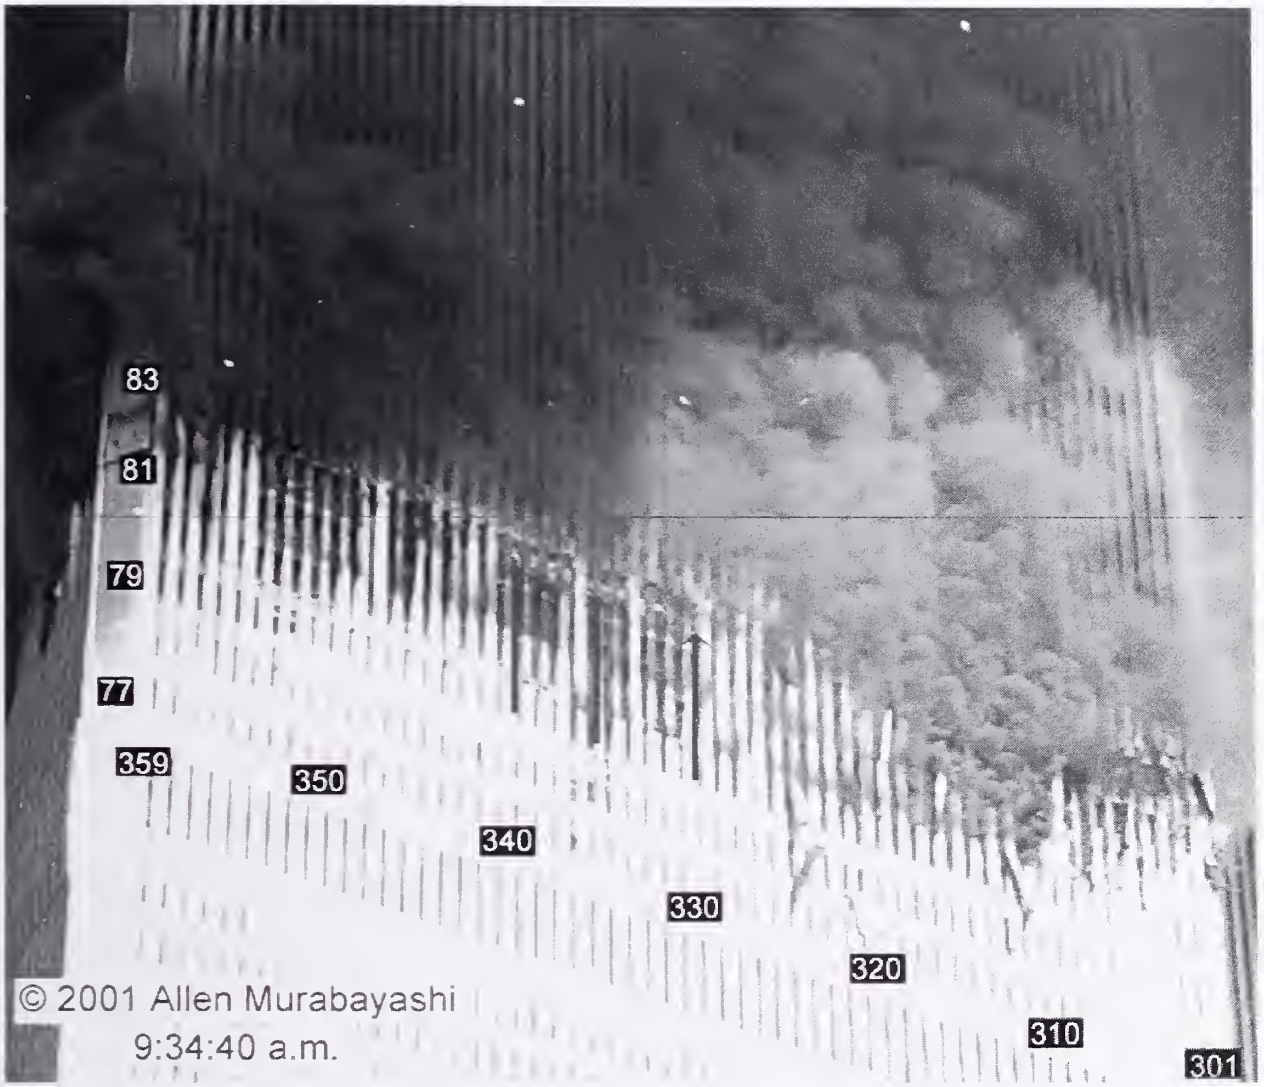
A relatively close view of the east face shot from southeast of WTC 2 at 9:34:40 a.m. is shown in Figure 9–40. This photograph was taken during a period when the flow of smoke coming from windows on the northern side of the 79th floor was fairly heavy, but when little smoke was coming from other windows below the 82nd floor. In Figure 9–27, taken at 9:25:47 a.m., windows 79-314 to 79-320 on the 79th floor had glass in place. These windows are open in Figure 9–40, suggesting that a fire must be burning nearby. The southern half of the face is visible to the tops of 83rd floor windows. Flames are

visible on the 82nd floor from window 82-322 to window 82-328. The fire on this floor has continued its spread toward the north since 9:27:35 a.m. (see Figure 9–28 and Figure 9–30 and related discussion). The fire burning in and near the northeast corner of the 81st floor is also visible in the photograph.

The arrows in Figure 9–40 indicate the hanging object that was described earlier. The appearance of the object is much the same as in Figure 9–28, which was shot from a similar angle at 9:27:35 a.m. This indicates that the portion of the object that is visible has not moved a great deal in the intervening period.

Figure 9-40. This cropped photograph, shot from the southeast at 9:34:40 a.m., shows the east face of WTC 2. The intensity levels have been adjusted, and column and floor numbers have been added. The arrows highlight a hanging object observed through open windows on the 82nd floor.

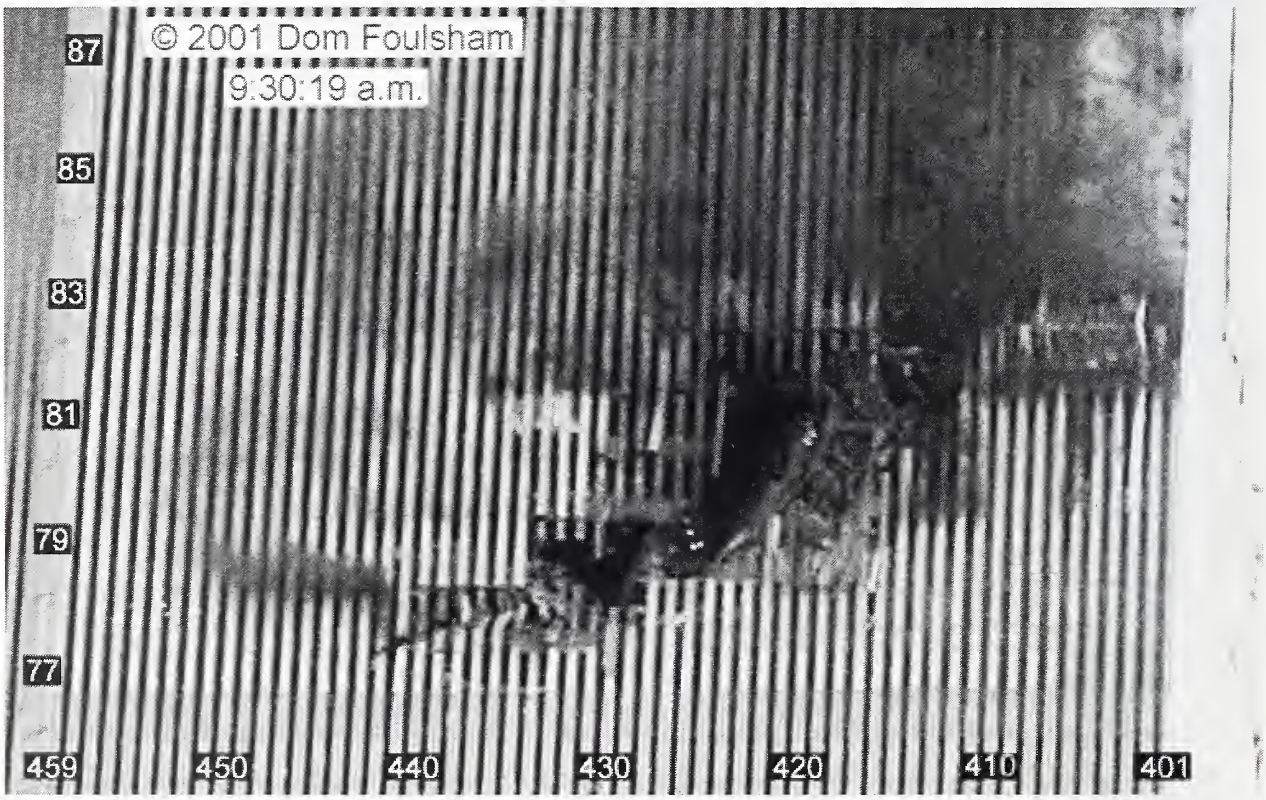
A view of the south face of WTC 2 at 9:30:19 a.m. is shown in Figure 9–41. It was taken just over 2 min later than the image of the face in Figure 9–33. One difference between the images is immediately apparent. Smoke is coming from windows to the west of the aircraft impact cavity on the 79th, 80th, and 82nd floors that was not present in the earlier photograph. The flames visible on the 81st floor are also much brighter. This picture was taken during one the smoke releases identified on the east face, and the presence of smoke and increased flame is likely associated with the same event.

In Figure 9–41, flames are visible on the 83rd floor in window 83-424. This is the first visual evidence of a fire burning on the 83rd floor on the south face. The fire on the 82nd floor between the aircraft impact cavity and the east edge has decreased in intensity, and the smoke has cleared up since Figure 9–33 was taken. Part of the 83rd floor is now visible. It appears as if the spandrel covers at the base of this floor are missing below windows 83-401 to 83-407. There does not appear to be an active fire on this part of the 83rd floor. The small fires burning elsewhere around the aircraft impact cavity have similar appearances to those observed at the earlier time.

Figure 9-41. This cropped photograph shows the south face of WTC 2 at 9:30:19 a.m. The image has been rotated, and column and floor numbers have been added.

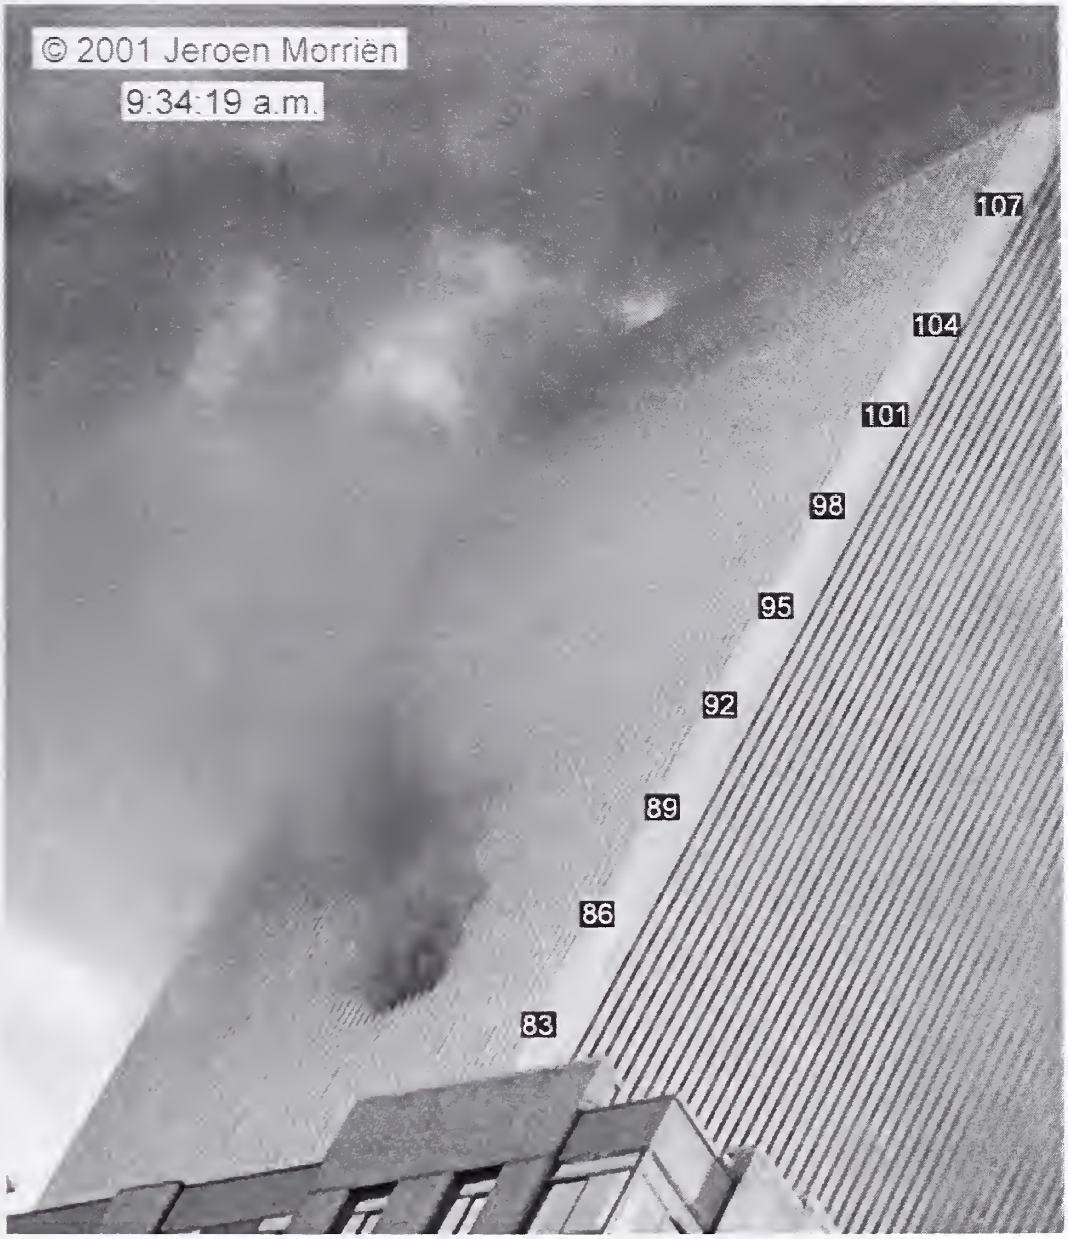
An oblique view of the west face of WTC 2 at 9:34:19 a.m. is shown in Figure 9–42. Smoke is visible at several locations on the west face. The densest smoke is flowing from windows 86-117 to 86-122 on the 86th floor. Lighter smoke is flowing from near window 88-142 and window 84-149 on the 88th and 84th floors, respectively. Smoke is also visible at two locations near the top of the tower; on the 107th floor,

where it was observed earlier, and at the top next to the southwest corner. The latter smoke flow is much lighter and is barely discernable in the photograph. In other images (not shown) it is more distinct. This smoke appears to be flowing from windows 108-101 and 108-102, which were located on the lower level of the mechanical equipment room that spanned the 108th and 109th floors. The nearest louvers to these windows are for a fresh air intake for the 107th floor observation area located opposite windows 108-101 to 108-109 (see Figure A-1 in Appendix A). This suggests that the smoke coming from the upper mechanical equipment room is back flowing through the fresh air intake for the 107th floor. Each of the locations with smoke flow on the west face is above the floors where fires have been observed, which is consistent with the possibility that people broke the glass out and released local build-ups of smoke.

Figure 9-42. This cropped photograph shot from the southwest shows an oblique view of the south and west faces of WTC 2 at 9:34:19 a.m. The intensity levels have been adjusted, and floor numbers have been added.

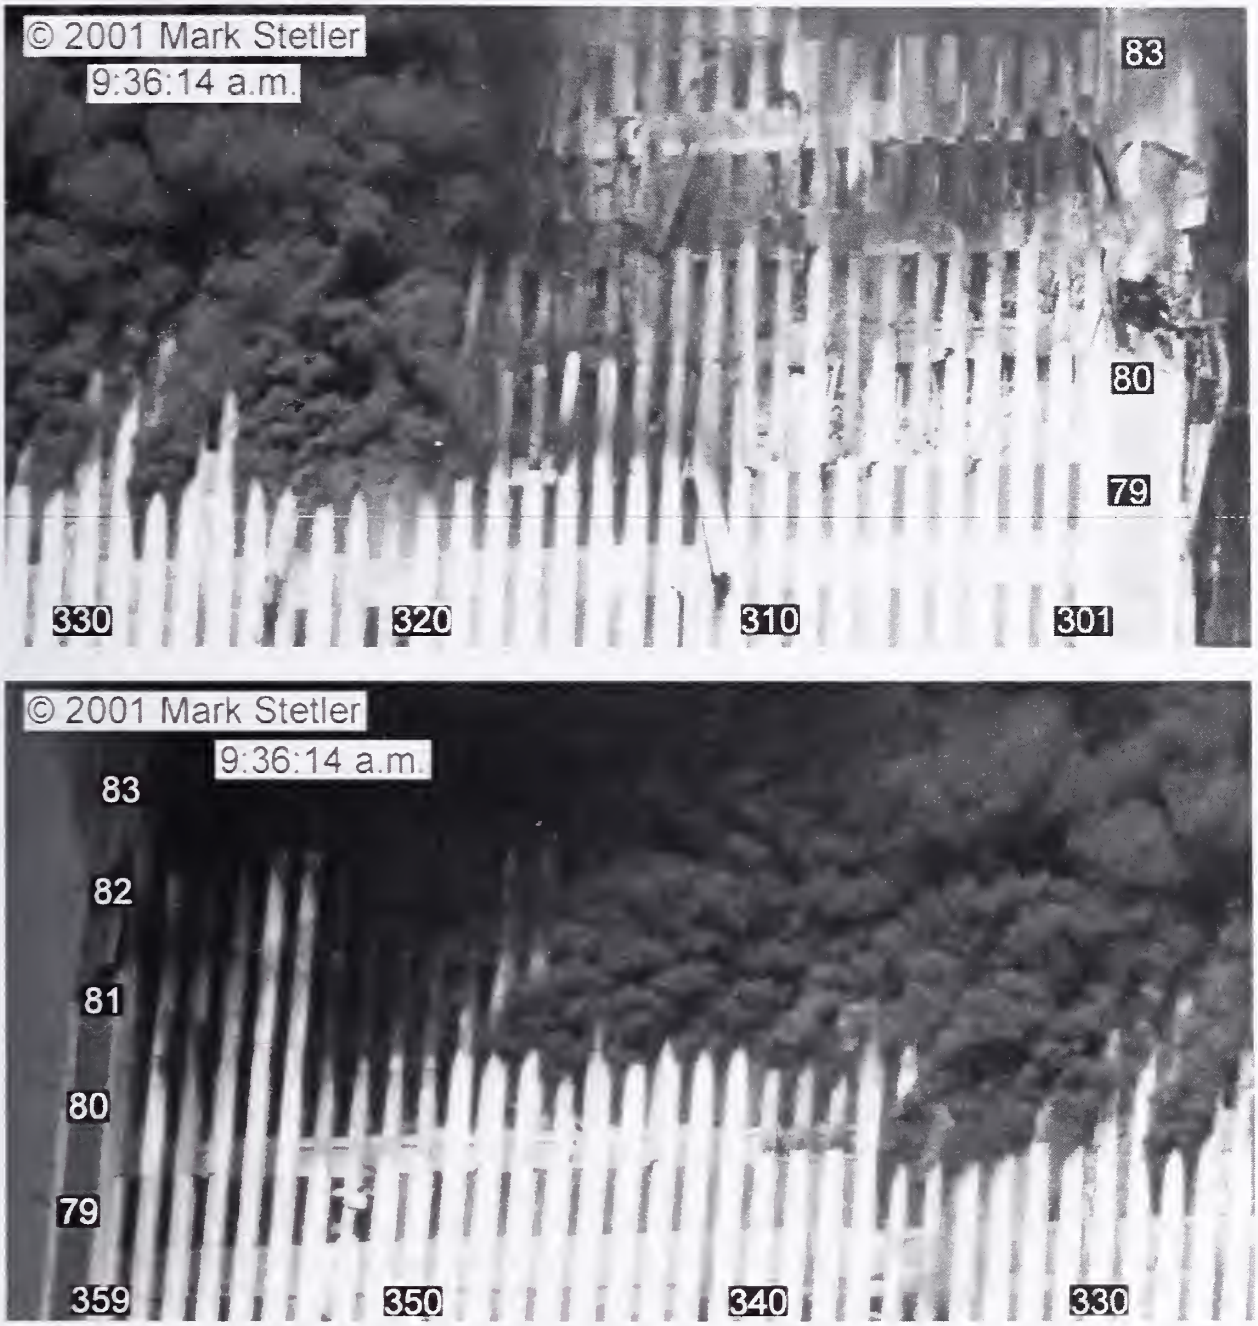
flow from these windows has apparently completely halted, but now heavy smoke and fire are visible over a range of windows from window 79-318 to window 79-336. In Figure 9–44 it is apparent that smoke and, in many cases, fire are coming from every window that is open over this range. Windows 79-326, 79-329, 79-330, and 79-332 still have glass in place.

The intense fire in the northeast corner opening of the 81st floor is still present. An unusual flame is visible within this fire. In the upper photograph in Figure 9–44 a very bright white flame, as opposed to the typical yellow or orange surrounding flames, which is generating a plume of white smoke, stands out. The intensity of this flame is considerably brighter than normal flames. It was easily identified in numerous photographs and videos shot from long distances at which the surrounding "normal" flames were not visible. The brightness of the flame, along with the white smoke, suggests that some type of metal is burning. Metal combustion is known to generate much higher flame temperatures than hydrocarbon combustion, and, as a result, to burn much brighter. It is difficult to identify what type of metal is burning. Aluminum will burn, but in normal fires it usually melts instead because the metal surface is protected by an oxide layer that must be breeched before ignition can take place. Aluminum oxide melts at high temperatures that are not typically reached in normal fires. There were limited quantities of other metals on the aircraft that might also burn. Whatever the metal, the ignition of a metal fire is an indication of the significant heating of the debris that took place in the northeast corner of the 81st floor due to the prolonged intense burning in this area following the aircraft impact.

Figure 9-44. These two images show blow-ups of the north and south sides of the east face of WTC 2 taken from the photograph included in Figure 9–43, which was shot at 9:36:14 a.m. Column and floor numbers have been added

Given the large amounts of smoke coming from the central regions of the 81st and 82nd floors on the east face, there is surprisingly little smoke at the north and south ends of these floors. With the exception of a light smoke flow from windows 78-334 and 78-335 on the 78th floor, no smoke is observed coming from below the 79th floor. Videos show that short bursts of smoke did come from other open windows on the 77th and 78th floors during the heavy smoke release.

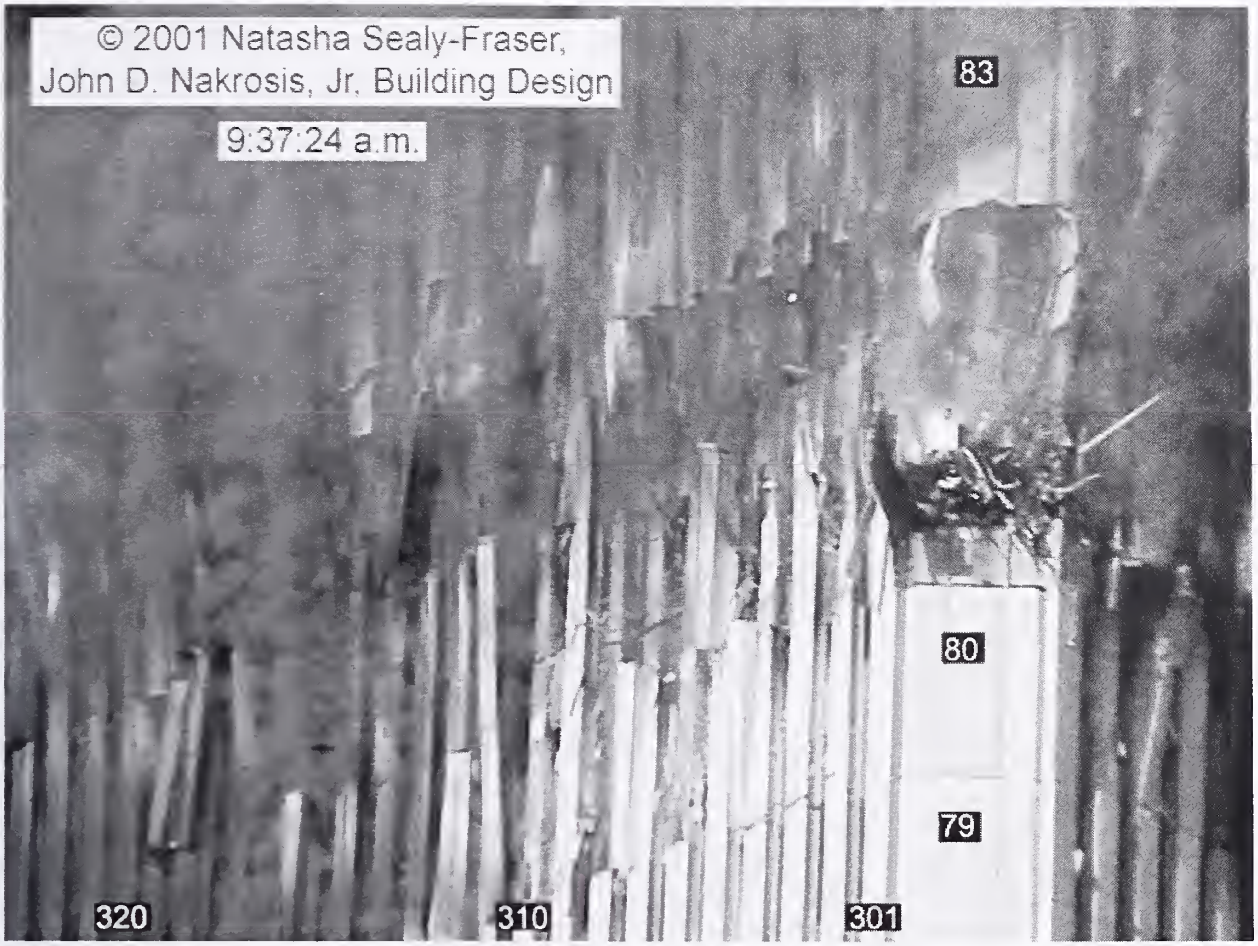
Figure 9–45 shows the northeast corner of the tower. The bright flame in the 81st floor corner opening, which has been attributed to metal combustion, stands out. A check of the original image shows that the pixels at this location are essentially saturated, providing an indication of how much brighter this flame was than the surrounding flames, which had intensities that were far from saturating the pixels. From this angle, flames are visible extending from the 82nd floor at windows 82-204 to 82-207. These windows appeared to be flame-free at 9:36:14 a.m.

Figure 9-45. This photograph was taken from the northeast at 9:37:24 a.m. and shows portions of the north and east faces of WTC 2. The intensity levels have been adjusted, and column and floor numbers have been added.

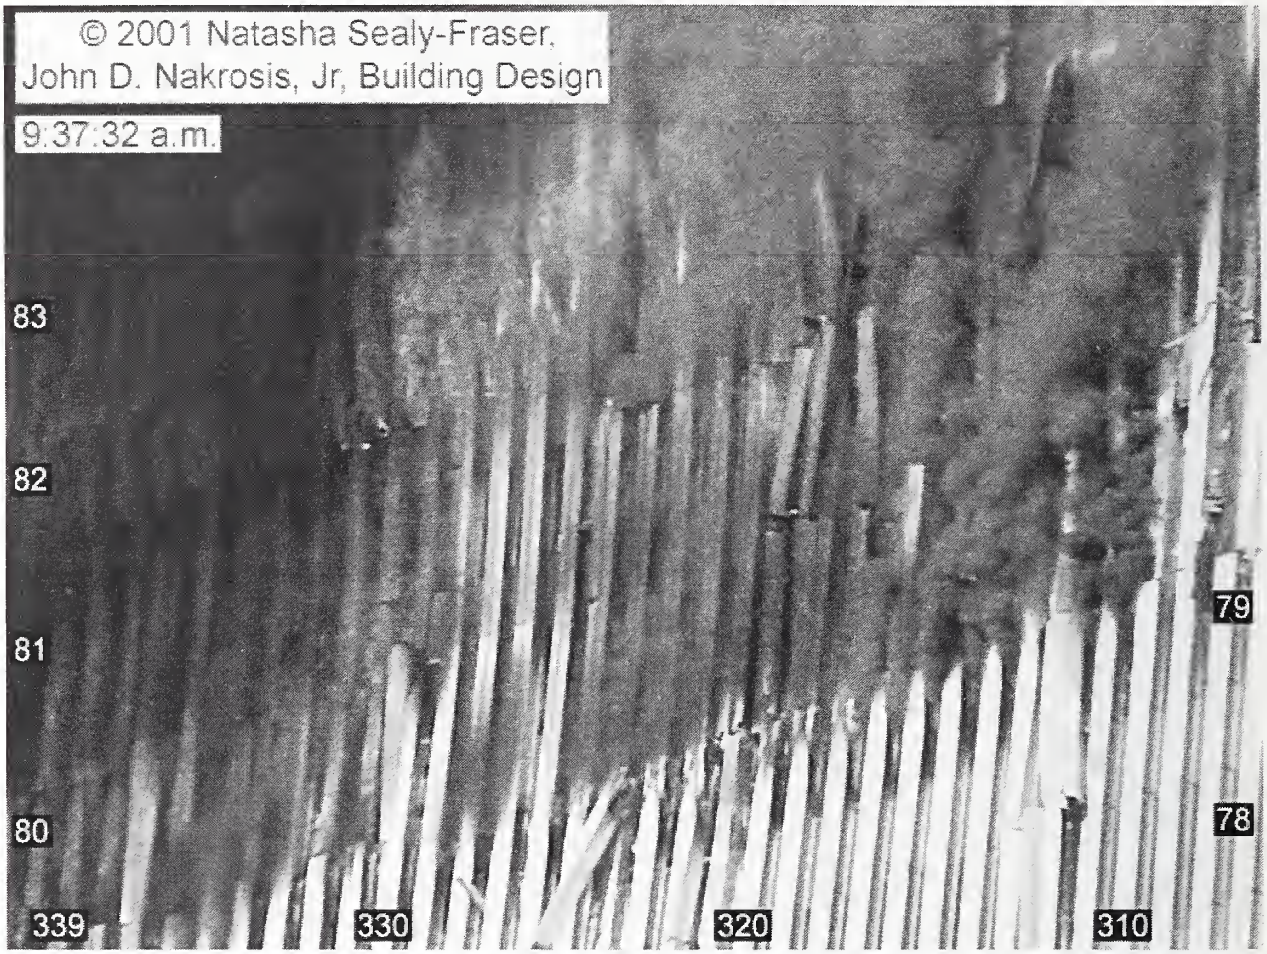
The largest changes in appearance occurred near the center of the east face. In Figure 9–46 the only heavy smoke and flames visible on lower floors is coming from windows 79-310 to 79-317 on the 79th floor. At 9:36:14 a.m. these windows appeared to be free of smoke and fire. On the other hand, the only evidence of the intense fires raging on the 79th floor seconds earlier in windows 79-318 to 79-325 are the carets visible at the tops of the adjacent column covers. Heavy smoke hid much of the upper floor façade in Figure 9–44. The only flames visible on the 82nd floor appeared to be just to the south of column 330. At the later time, large flames are coming from windows 82-320 to 82-333. Recall that intense flames became visible in this region around 9:37:18 a.m.

Closer inspection of Figure 9–46 reveals that the columns on the 80th and 81st floors on either side of column 330 appear to be bowed inward. This bowing could be identified in images taken as early as 9:21:29 a.m. Several additional photographs to be described below show a similar bowing. This indicates that columns on these floors were distorted at least 37 minutes prior to the collapse of the tower.

Figure 9-46. This photograph was taken from the northeast at 9:37:32 a.m. and shows the center portion of the east face of WTC 2. The intensity levels have been adjusted, and column and floor numbers have been added.

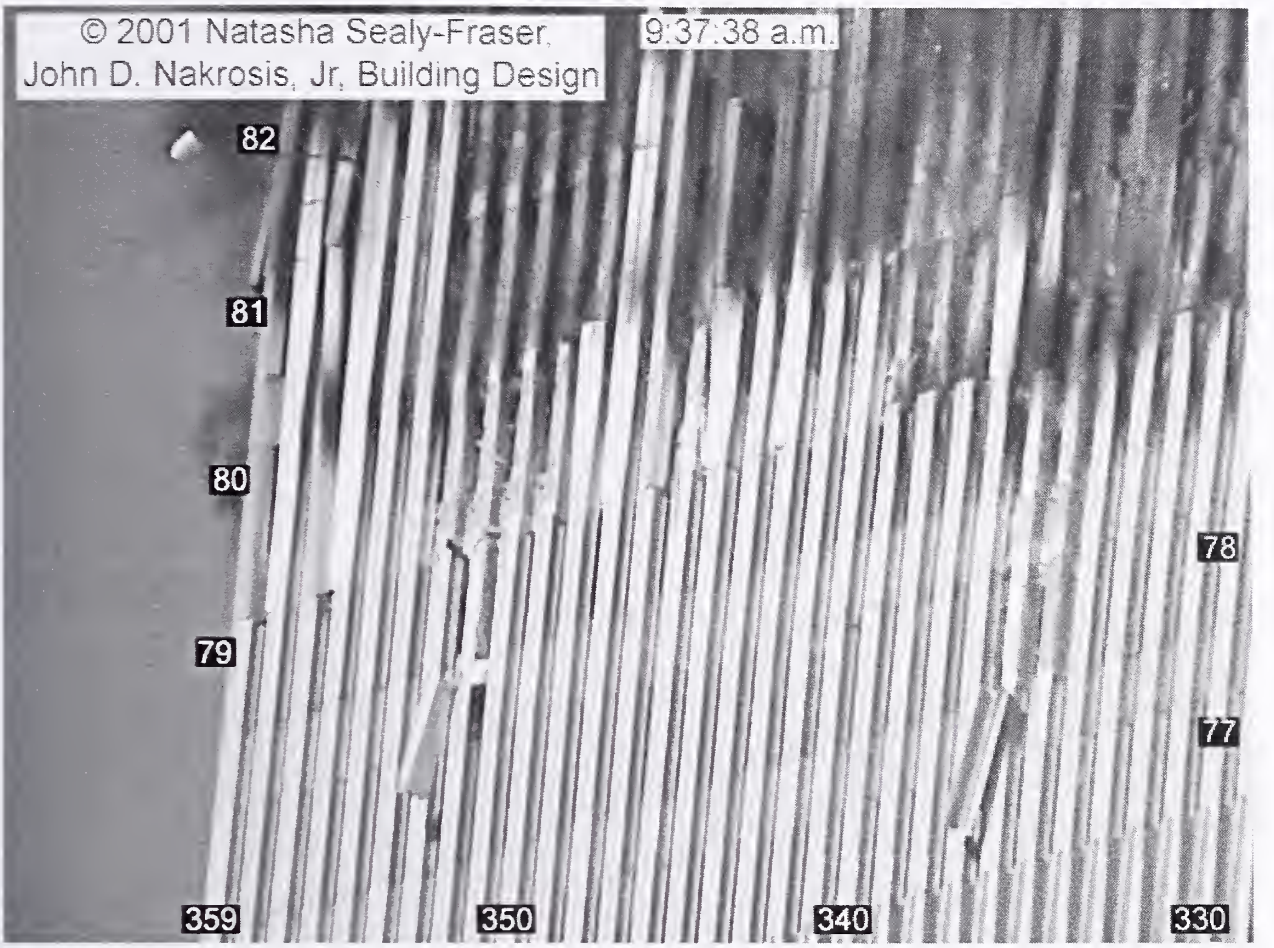
Figure 9–47 show the southern portion of the east face. There is very little smoke and no fire coming from windows in this area. This contrasts sharply with Figure 9–44, in which intense flames and large amounts of smoke were visible coming from numerous windows on the 79th and 80th floors.

Figure 9-47. This photograph was taken from the northeast at 9:37:32 a.m. and shows the western portion of WTC 2. The intensity levels have been adjusted, and column and floor numbers have been added.

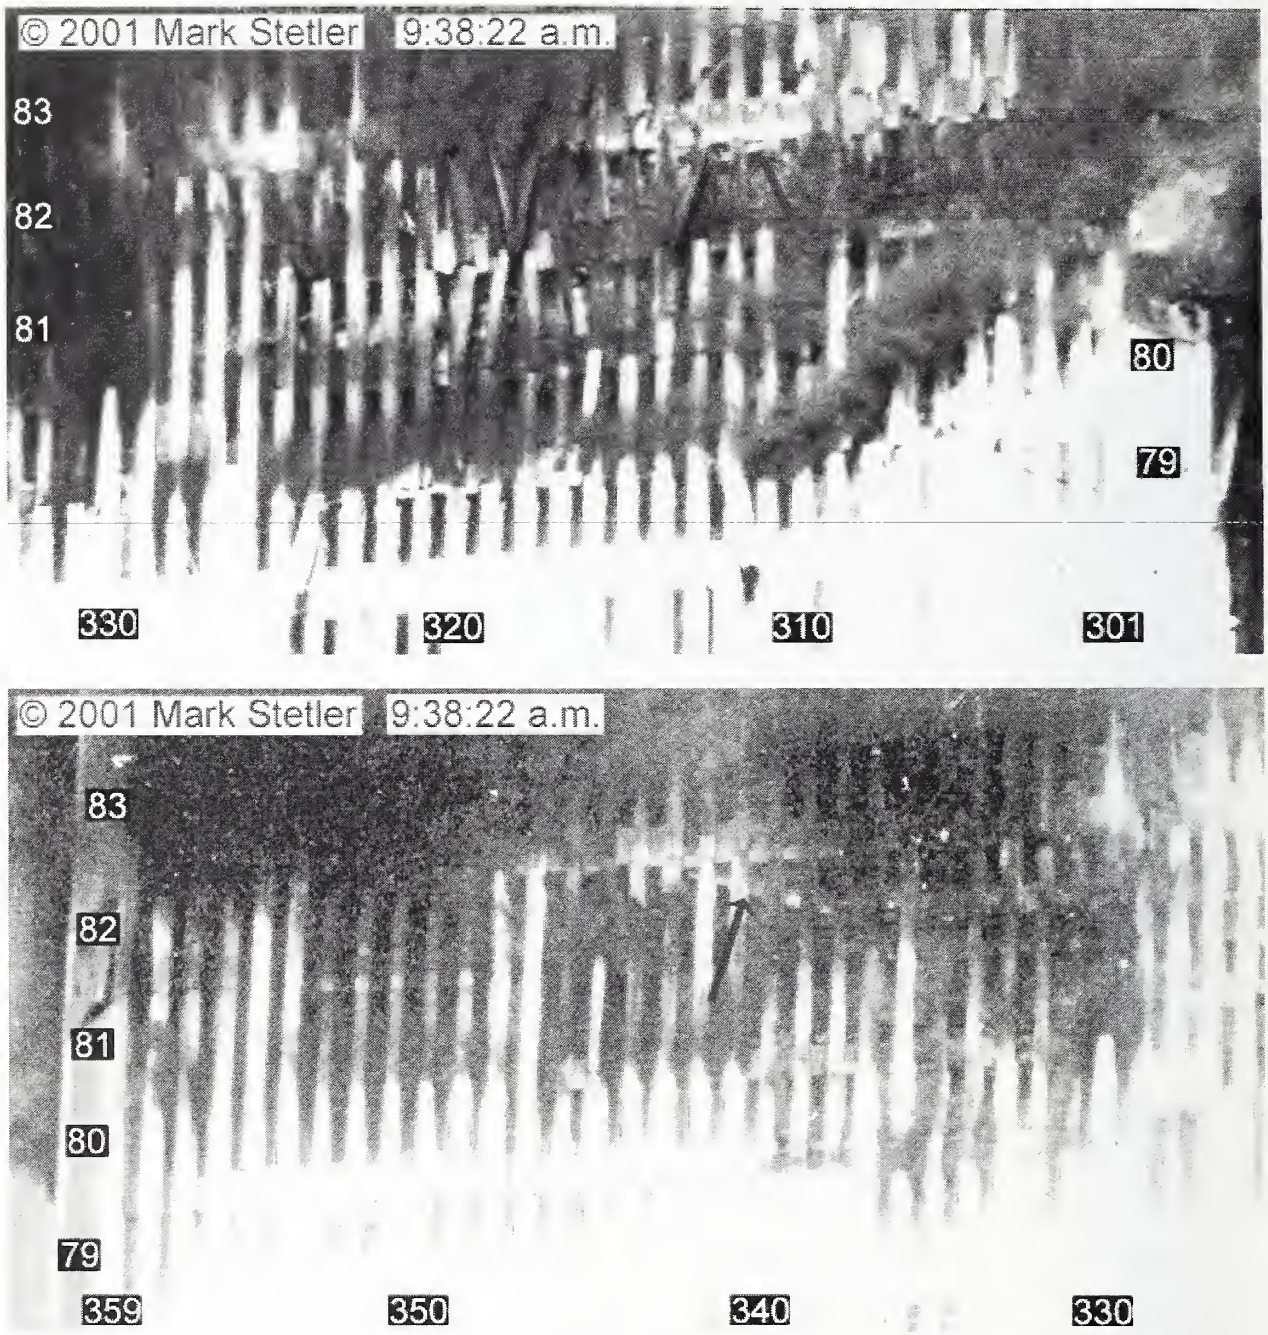
Views of the northern and southern sides of the east face enlarged from the same photograph taken at 9:38:22 a.m. from the east are shown in Figure 9–48. The intensities have been adjusted to overexpose much of the images in order to highlight the object marked with arrows. This is the same hanging object described earlier that has been tentatively identified as the 83rd floor slab. Its appearance has now changed from those seen in Figure 9–1 and Figure 9–2 (9:03:42 a.m.), Figure 9–21 (9:18:38 a.m.), Figure 9–28 (9:27:35 a.m.), Figure 9–31 (9:26:20 a.m.), and Figure 9–40 (9:34:40 a.m.). At these earlier times, the object was visible hanging near the tops of open windows 82-321 to 82-342, even though it did shift downward locally between 9:18:38 a.m. and 9:26:17 a.m. In the bottom image of Figure 9–48, it can still be seen at the top of window 82-342, but now it drops very rapidly and seems to disappear below the base of window 82-337. The object is no longer visible in windows at least as far to the right as window 82-330. Windows immediately to the north of window 82-330 are filled with fire that would hide the object even if it was above the window base.

In the top portion of Figure 9–48, the visible fire area near the center of the 82nd floor ends at window 82-318. Beyond this point, it is possible to see inside the windows again, and the hanging object (marked with arrows) is visible starting near the base of window 82-317 and rising toward the top of window 82-311. This location is 10 windows further north than where the object was seen earlier. These observations suggest that the object, which may have been the 83rd floor slab, that had been hanging near the tops of windows on the 82nd floor since shortly after the aircraft impact sank much lower sometime between 9:34:40 a.m. and 9:38:22 a.m. At some unknown time an additional length of the object became visible on the north side. The fire that had reappeared at the northern edge of the 82nd floor in Figure 9–45 continued to burn at 9:38:22 a.m.

In the top part of Figure 9–48, an extensive fire can be seen on the 79th floor between windows 79-310 and 79-320. There had been indications of a fire in this area prior to the sudden release of smoke and fire (see Figure 9–40). Isolated fires are also visible on the 81st floor at window 81-331 and on the 80th floor at windows 80-338 and 80-339, with flames extended from window 80-339. These latter fires are the only visible remnants of the large fires visible on these floors in Figure 9–43 and Figure 9–44.

Figure 9-48. These two images show blow-ups of the north and south sides of the east face of WTC 2 taken from a photograph that was shot at 9:38:22 a.m. The intensities have been adjusted to purposefully overexpose parts of the images. Column and floor numbers have been added

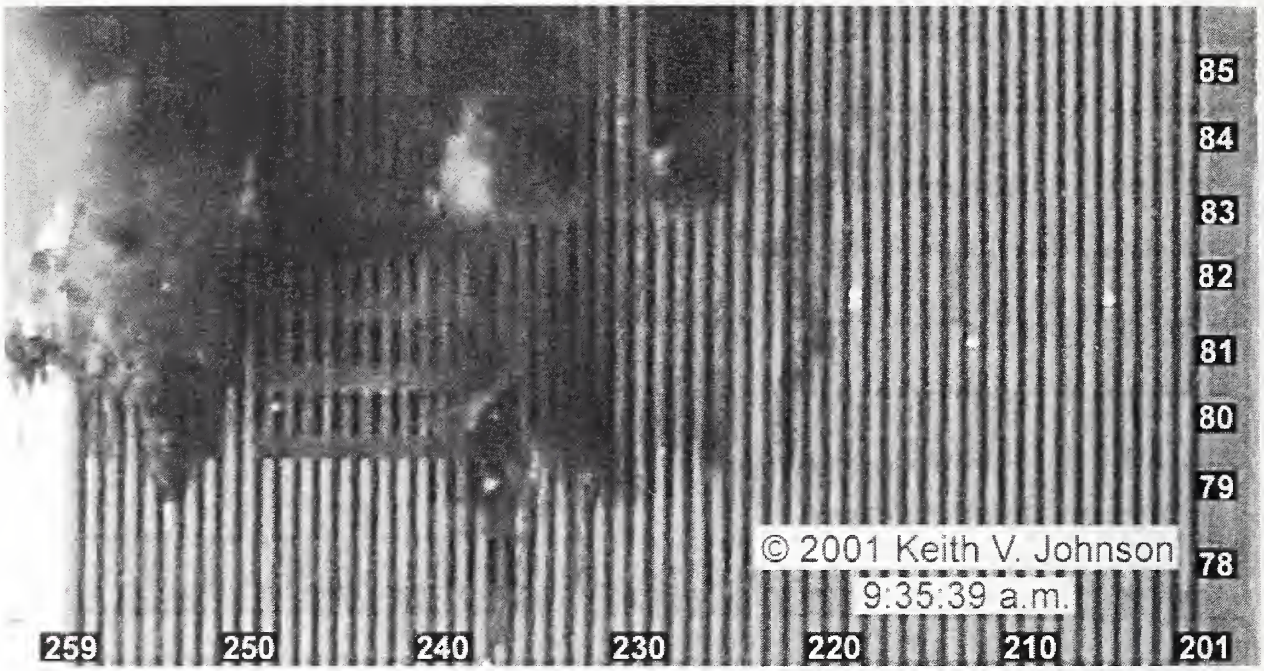
Figure 9-49. This cropped photograph shows the north face of WTC 2 at 9:35:39 a.m. The intensity levels have been adjusted, and column and floor numbers have been added.

The fire distributions elsewhere on the north face in Figure 9–49 are similar to those in Figure 9–36 and Figure 9–37. Fires were still burning at the east edge of the tower on the 81st, 82nd, and 83rd floors. The debris piles on the 78th floor and in the lower right-hand corner of the cold spot continued to burn, and fire was visible as far west as window 79-225 on the 79th floor. A plume of smoke is visible coming from window 79-222. There are no visible indicators of fire to the west of this window on any of the floors.

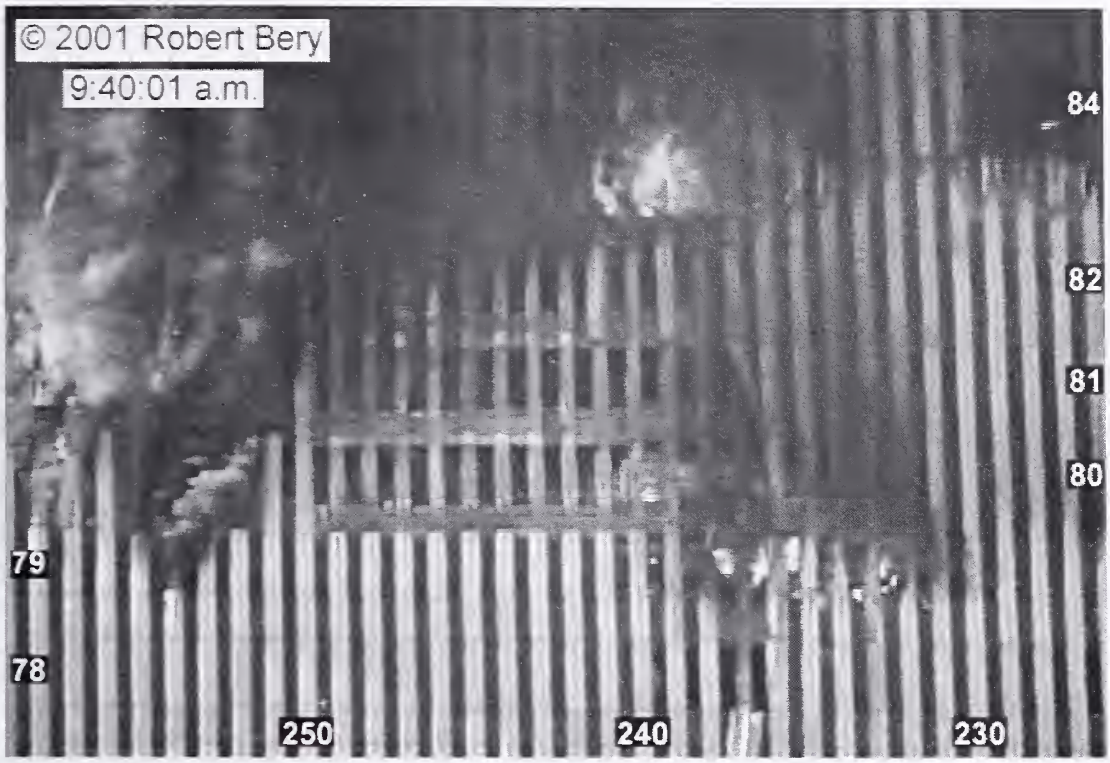
A somewhat closer view of the north face taken at 9:40:01 a.m. is shown in Figure 9–50. Even though the image contains some digital noise, it is sufficiently resolved that open and closed windows can be identified. By this time, the fire visible in windows 83-226 to 83-229 on the 83rd floor no longer had extended flames. The carets on the surrounding aluminum column covers reflect their earlier presence. The three windows immediately to the east, windows 83-230 to 83-232, appear to still have glass in place. Flames continue to extend from windows on this floor above the right-hand side of the cold spot, but flames in windows 83-234 to 83-236 have died down sufficiently that they are no longer visible. Carets around these windows indicate that extended flames were present earlier. The fire on the eastern edge of the 81st floor continues to burn vigorously, hiding the locations immediately above on the 82nd and 83rd floors. The fires burning on piles of debris on the 79th and 80th floors have comparable intensities to those seen in recent images.

Figure 9-50. This frame captured from a video shows the north face of WTC 2 at 9:40:01 a.m. The intensity levels have been adjusted, and column and floor numbers have been added.

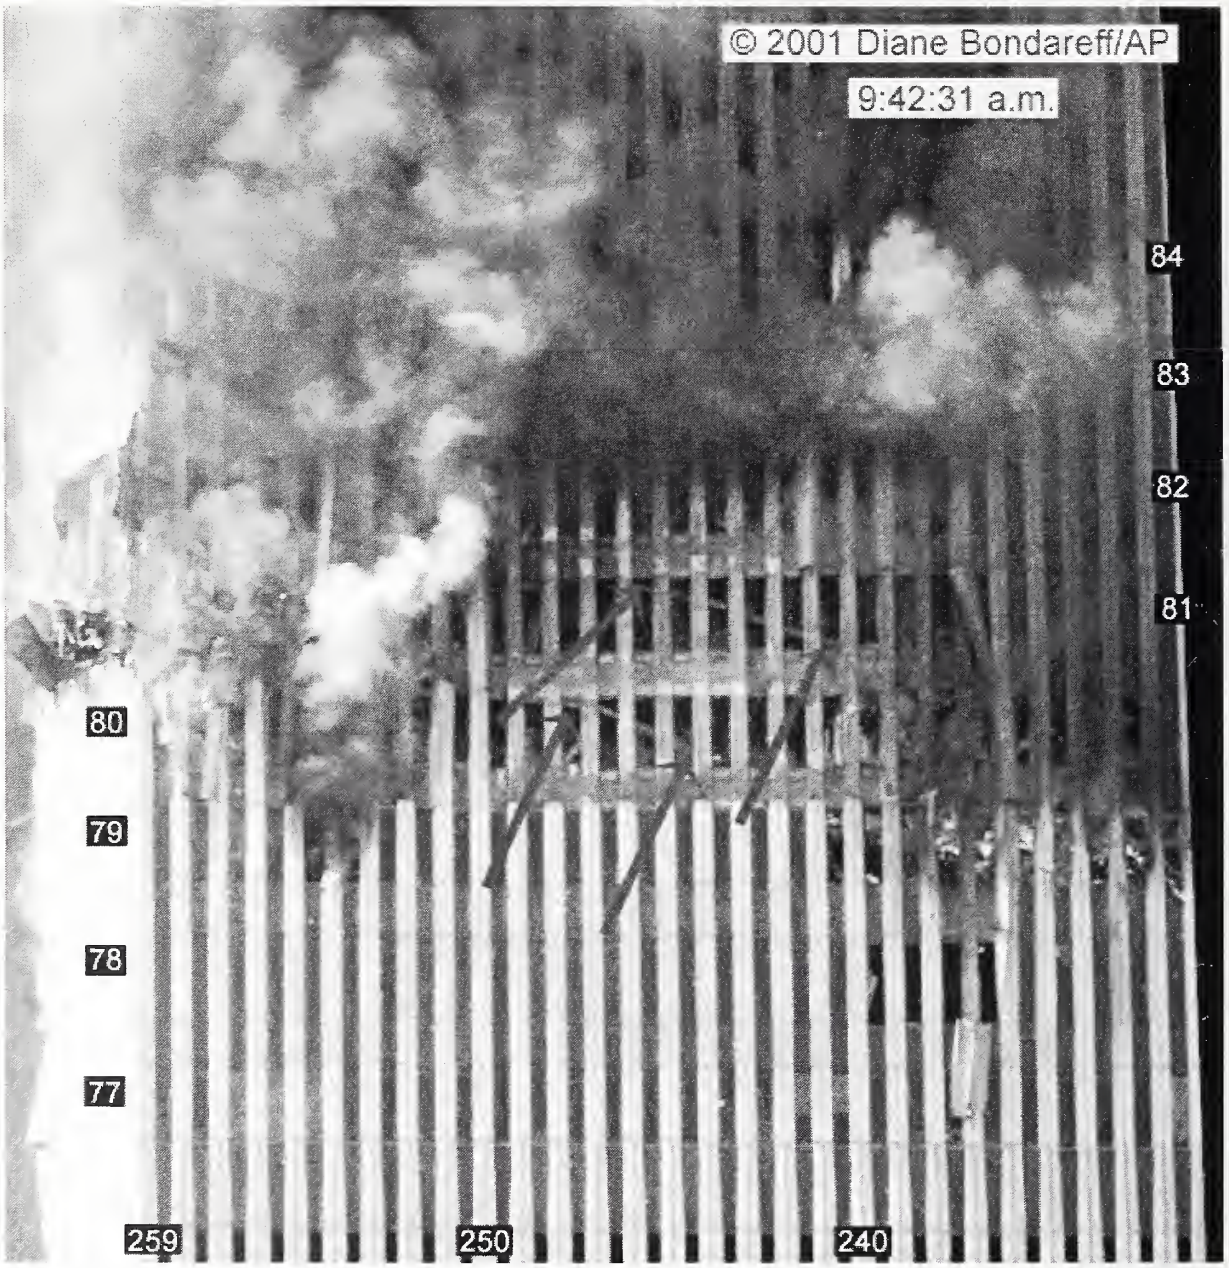
A high-resolution photograph of the area around the cold spot on the north face is reproduced in Figure 9–51. It was shot at 9:42:31 a.m. Arrows have been added to the image to indicate hanging objects that are visible through open windows on the 80th and 81st floors. The area containing the arrows is blown up further in Figure 9–52. It is instructive to compare this image with Figure 9–17, which shows a blowup of roughly the same area at 9:14:03 a.m., and Figure 9–12, which was recorded at 9:10:01 a.m.

Figure 9-51. This cropped photograph shows a portion of the north face of WTC 2 at 9:42:31 a.m. The image has been rotated and enhanced by adjusting the intensity levels, and column and floor numbers have been added. The arrows highlight hanging objects visible through open windows on the 80th and 81st floors.

Figure 9–51 provides good views of the fires that continued to burn on the east edge of the north face on the 81st and 82nd floors and on the piles of debris on the right side of the cold spot on the 79th and 80th floors. Flames are also visible on the 83rd floor in windows 83-238 to 83-244. All of these fires have similar appearances to those seen in recent earlier photographs.

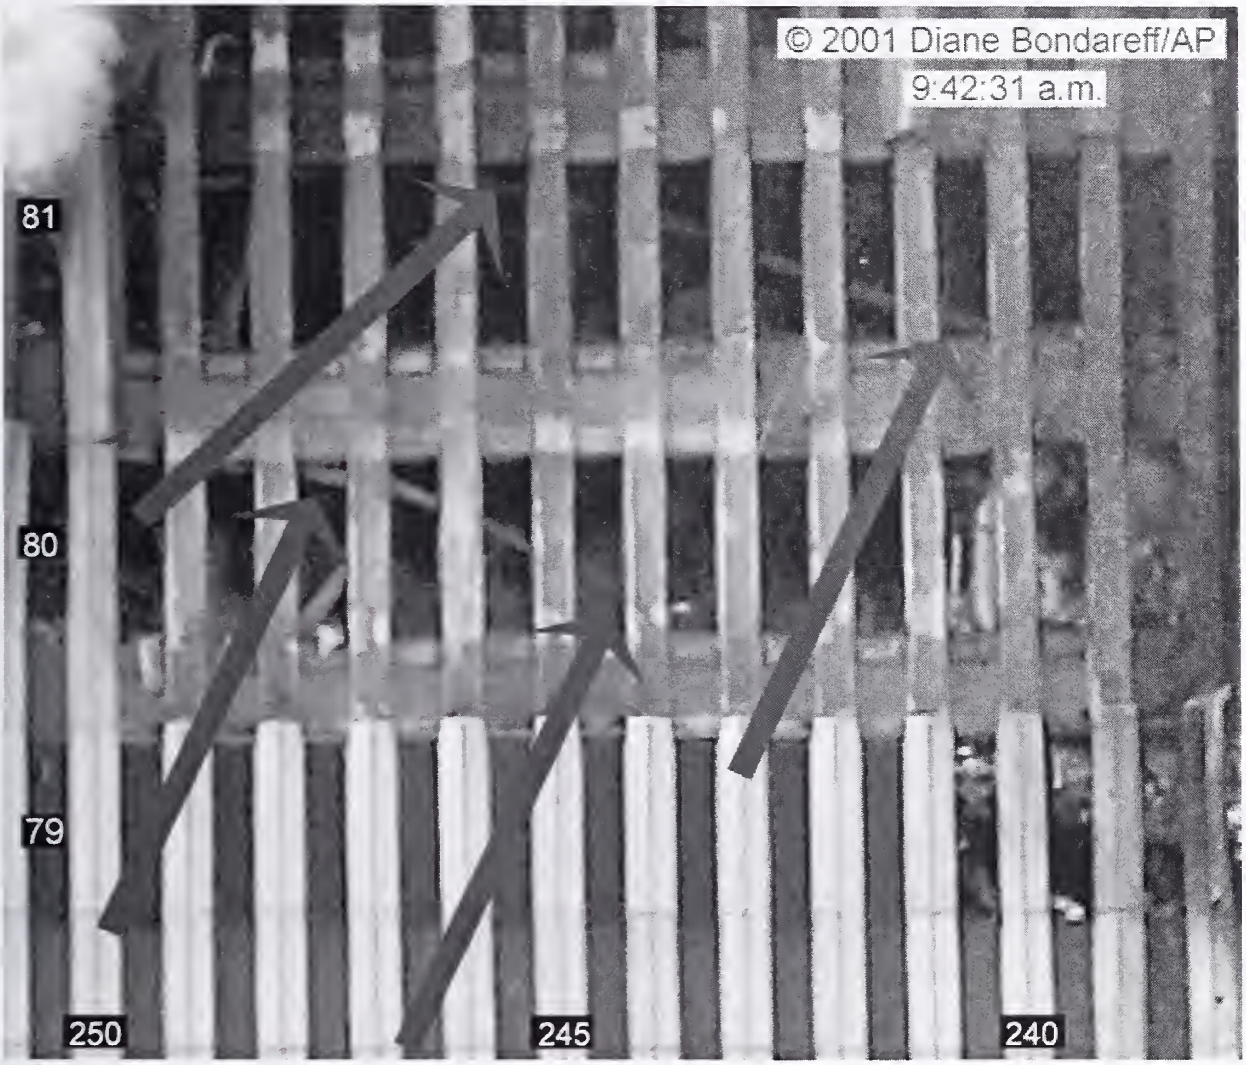
Hanging objects are visible in the two blow-ups shown in Figure 9–17 and Figure 9–52, but it is apparent that their locations and appearances have changed between the times when the two photographs were taken. At the earlier time, two objects were observed through open windows in the cold spot on the 80th floor. The first was located near the center of the windows and extended across the entire area, reaching as far east as window 80-255. The second was visible curving downward in window 80-247 and extending to near the center of window 80-242. In Figure 9–52 the lower object has apparently disappeared completely from view, and the object that was hanging higher up in the windows has dropped down. It now first appears in window 80-248 and curves rapidly downward, seeming to disappear below the spandrel at the base of window 80-243.

In the earlier blow-up there appeared to be two objects hanging in the cold spot on the 81st floor just below the tops of windows 81-239 to 81-242. In Figure 9–52 only a single object is visible through windows in this area of the 81st floor. It now first appears in window 81-245 and curves downward to the base of window 81-240. This object has also apparently shifted position.

Figure 9-52. A section of the image shown in Figure 9–51 is blown up. The arrows point to the locations of hanging objects that are visible through open windows on the 80th and 81st floors on the north side of WTC 2. Column and floor numbers have been added.

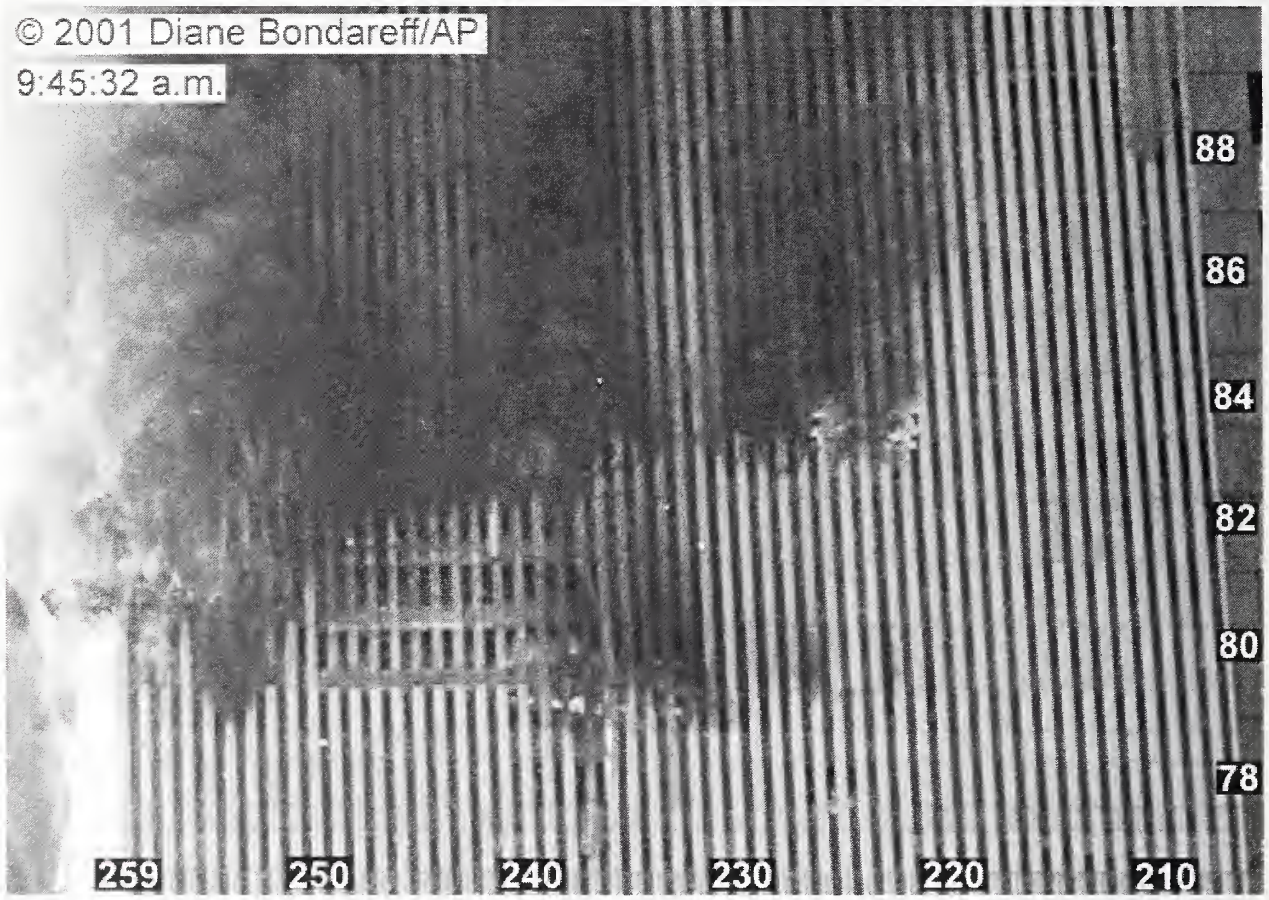
coming from windows 83-221 and 83-224. Flames are no longer visible in windows 83-226 to 83-230, even though carets are visible on adjacent column covers. Windows 83-225, 83-231, and 83-232 appear to have glass in place. The sudden and isolated development of a fire on the 83rd floor in windows 83-221 to 83-224 suggests again that flashover within a room has occurred. The fire on this floor near the left edge of the cold spot has died down with internal flames only visible in windows 83-238 and 83-239.

Figure 9-53. This image of the north face of WTC 2 was taken at 9:45:32 a.m. The photograph has been cropped and rotated, and the intensity levels have been adjusted. Column and floor numbers have been added. The brown area to the right is the eastern edge of WTC 7.

The fire burning on the eastern edge of the north face on the 81st floor continues to burn vigorously, but flames are not visible in the 82nd floor windows at this time. A small fire is visible in window 83-259 on the 83rd floor. The fires on the 79th and 80th floors near the center of the north face continue to burn on the piles of debris. Fires are not evident on the 79th floor to the west of window 79-230, even though smoke marks and open windows at 79-220 and 79-222 are evidence of the earlier burning observed in this area.

In Figure 9–53 an isolated smoke plume is visible on the 88th floor coming from window 88-208. This is another location where it is possible that people have broken out a window. A photograph shot just before 9:45 a.m. showed that windows 88-201 to 88-203 were also open.
